# Bridge restoration

- Shiga Prefecture Taka Town
- National Route 306
- Hosohara Bridge
- Objective(s):
- Remove failing paint and apply new coating system

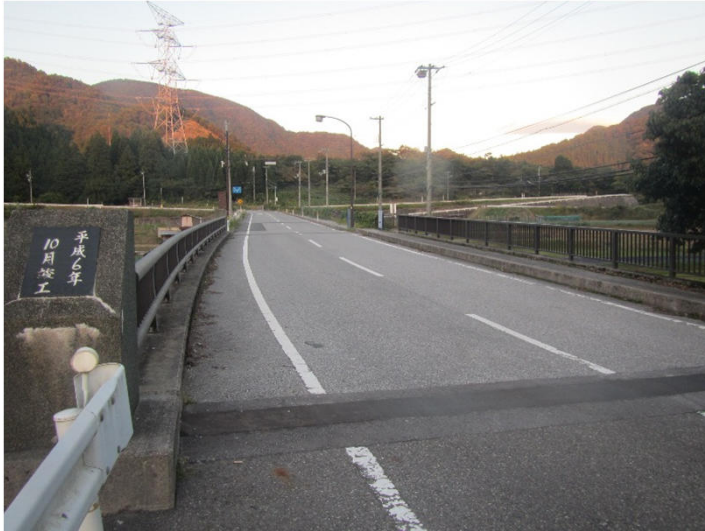
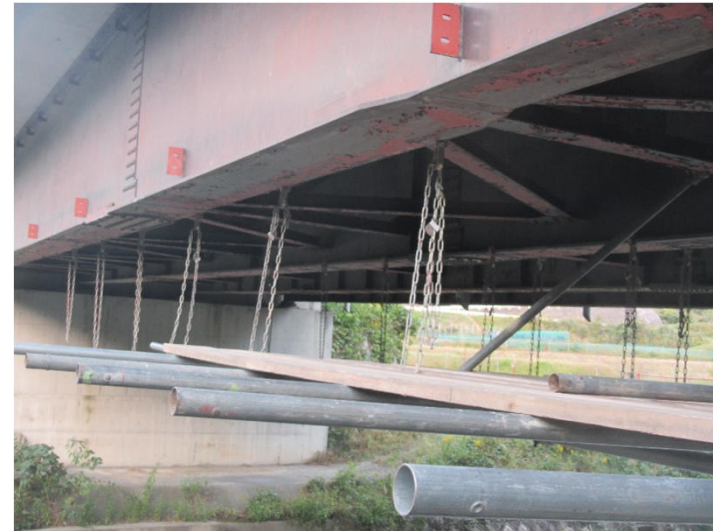
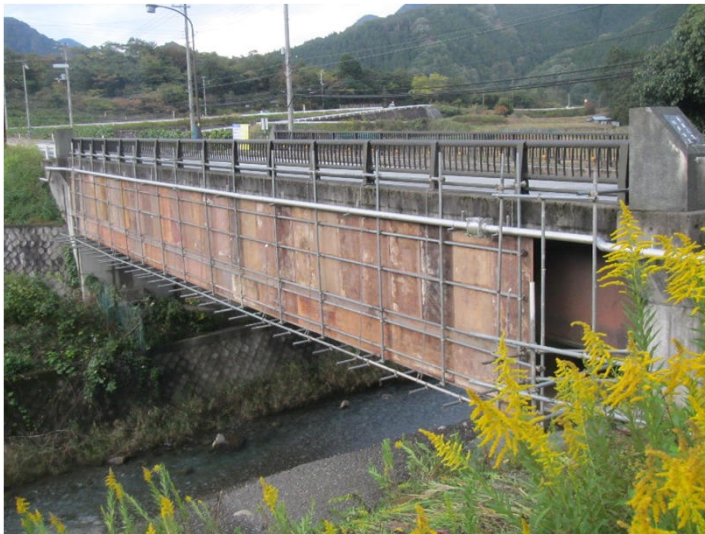
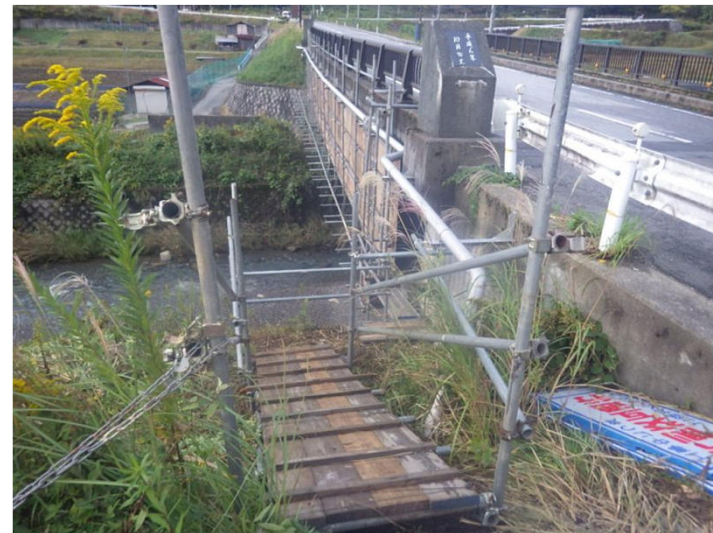
- **Substrate Type: Steel**
- **Surface Condition:**  
Corrosion and failing lead-based paint
- **Project Size :** 832m<sup>2</sup>(8953ft<sup>2</sup>)
- **Film Thickness :** 200  $\mu$
- **Specified Level of Cleanliness:**  
Sa- 2 ~ 2.5
- **Specified Profile:**  
Under 80  $\mu$  (3.2mil)

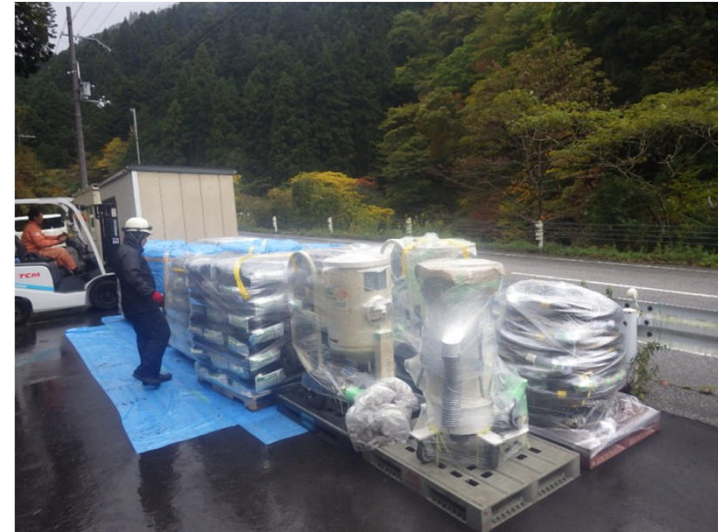
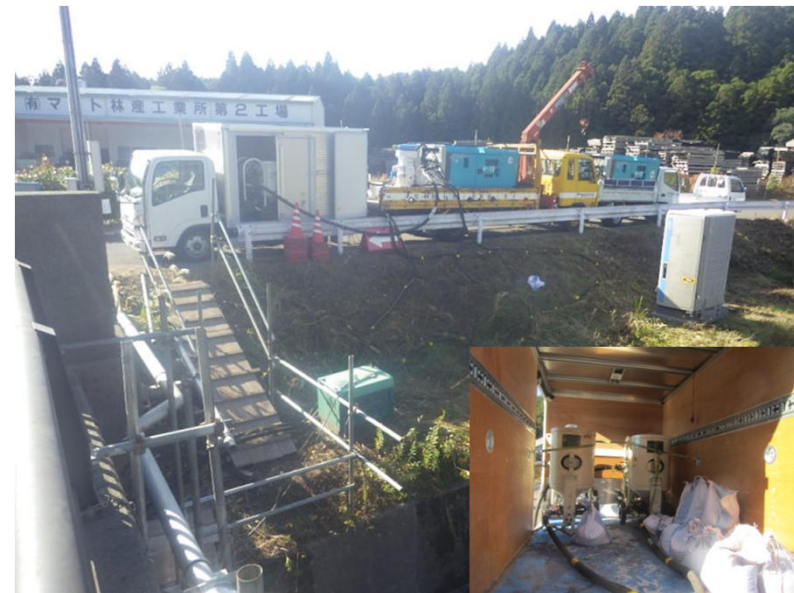
- 100-HP Feed Units™ × 2
- Silver 30 Sponge Media™  
×(150)bags → 3.3kg/m<sup>2</sup>

Removal Rate : 6.4m<sup>2</sup>/hr.

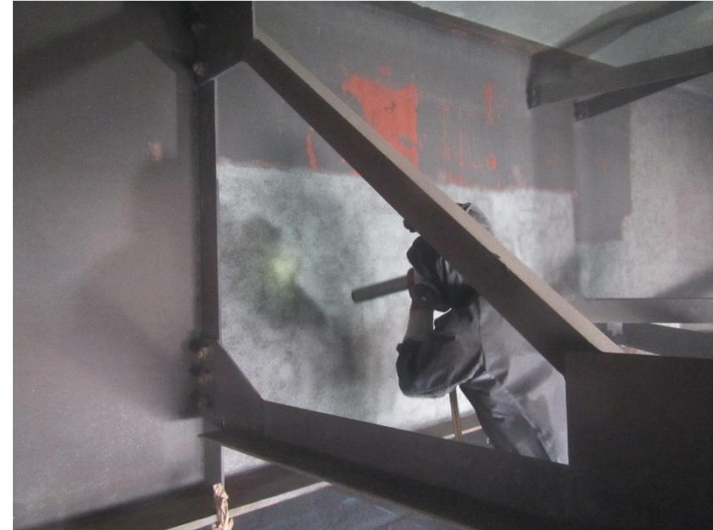
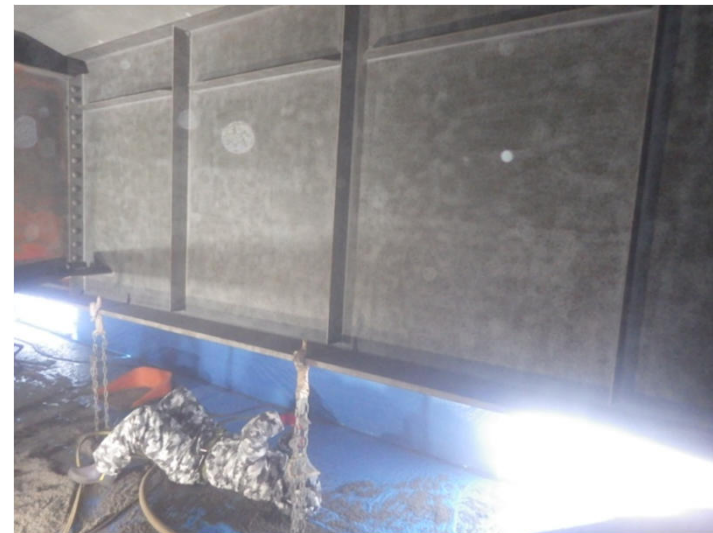
- A big compressor is necessary
- Collection work of Sponge media is complicated
